Manhole Inspection Summary

Manhole # S41E__061MH

Inspection ☐ Is Incomplete Rating: **5) Immediate Attention Required**

Location Address: **1116 n aisquith st**

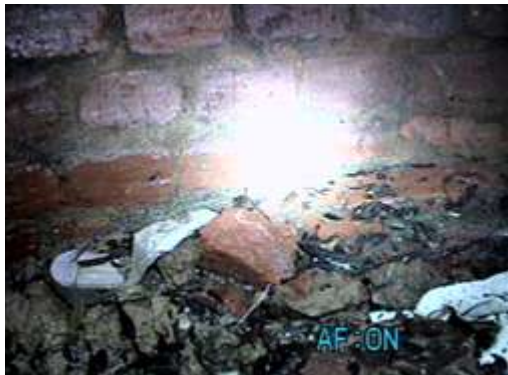
Defect 4

Condition: ☐ Sound ☐ Cracked ☐ Root Intrusion ☐ Deteriorated ☐ Leaks ☒ **Debris**

channel debris

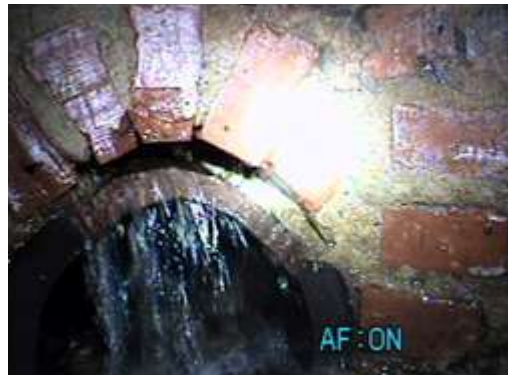
Defect 3

Infiltration: ☐ None ☒ **Joint** ☐ Cracks ☐ Mortar ☐ Roots ☒ **Wall**

infiltration just above 12

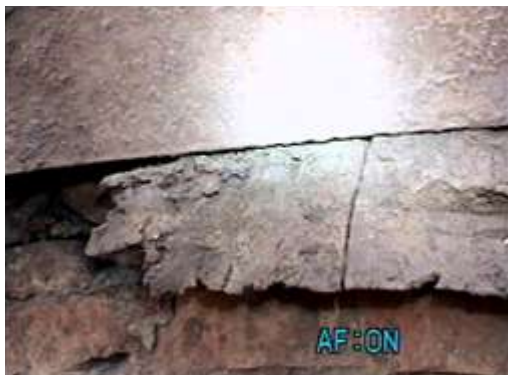
Defect 2

Condition: ☐ Sound ☐ Cracked ☐ Root Intrusion ☒ **Loose Brick** ☒ **Deteriorated**

chimney loose bricks and deteriorated,
frame adj

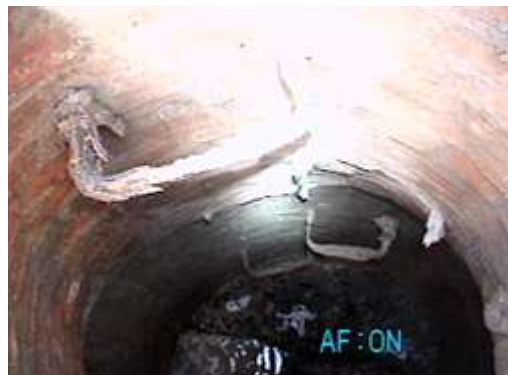
Defect 1

Count: **9** Missing: **2** ☒ **Corroded**

cor. steps

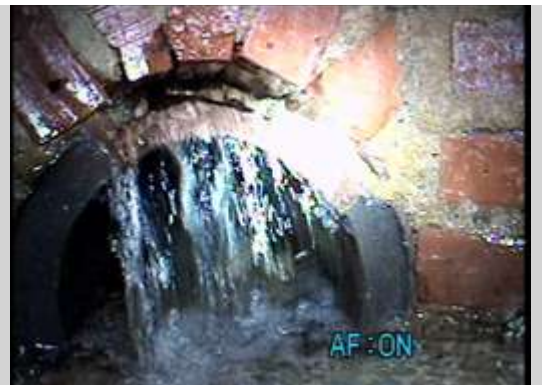
12 O'Clock Outflow

Infiltration: **Runner** Pipe Seal Cond: **Cracked**
